# NATIONAL MARITIME MUSEUM S A N F R A N C I S C O

CONDITIONS INVESTIGATIONS  
AND  
WATERPROOFING ASSESSMENT

SAN FRANCISCO MARITIME NATIONAL HISTORIC PARK  
NATIONAL PARK SERVICE

ARCHITECTURAL RESOURCES GROUP  
PIER 9, THE EMBARCADERO  
SAN FRANCISCO, CA 94111

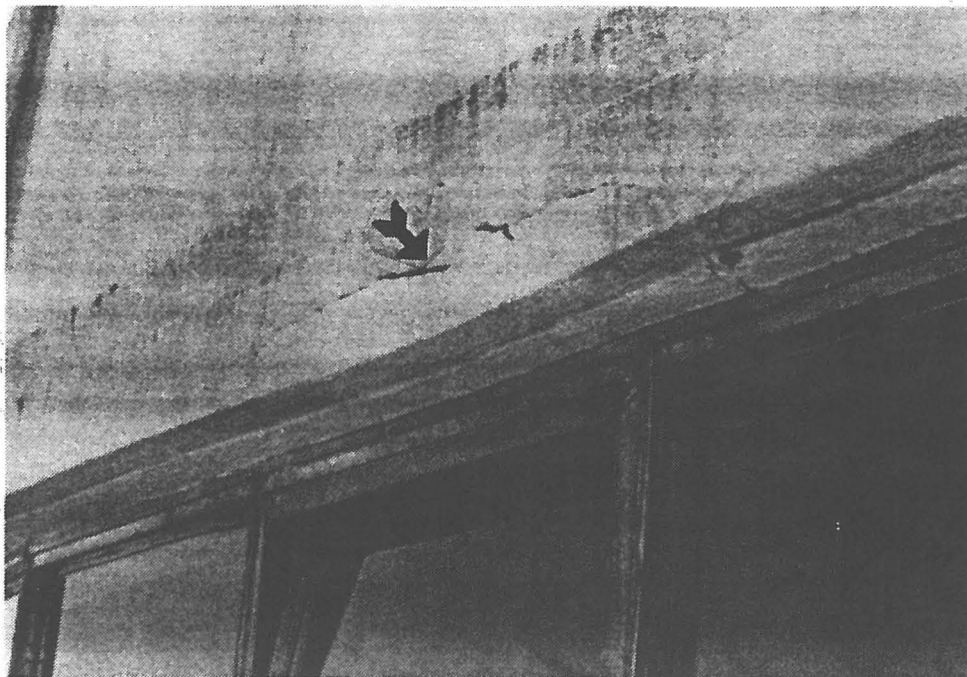
The reinforced concrete walls appeared to be in good condition, with minor losses at random locations which had been painted over and appear sound. (The specific conditions of windows and window jambs is discussed in a previous report by ARG). There is one large incipient spall on the north elevation of the penthouse above a window. The parging of the limestone coping caps was presumably necessary due to deterioration of the stone. It has been observed by ARG on other buildings in San Francisco that certain types of limestones do not weather well in this climate.

*Incipient spall over  
penthouse window on north elevation. Photo by ARG.*

The reinforced concrete walls have been painted within the last two years and are in good condition with no major repairs necessary. As mentioned, a scope of work for restoration of the Museum Building windows has been defined under a previous contract between ARG and NPS. This project will include minor repair of concrete at window jambs and adjacent surfaces in conjunction with restoration of the windows. Repair of the one large spall on the north wall of the penthouse is also included in this scope of work.

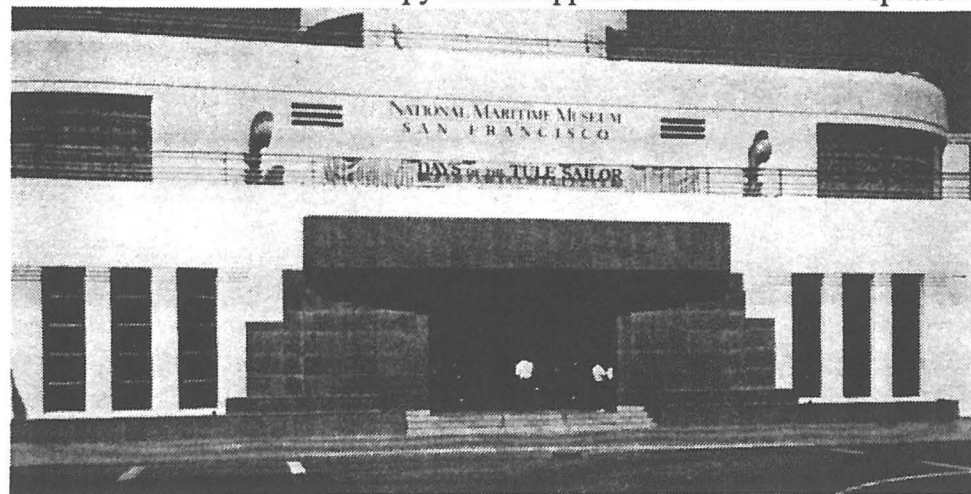
The bas-relief sculpture and the fountain are in poor condition. Essentially all mortar joints are open, and several fountain coping stones have become loose to the point that removal by vandals is possible. Hairline cracks and losses at arrises are numerous in both slate and terrazzo panels. Significant cracks were noted on a number of slate units (see photo on following page). A whitish discoloration is common near the slate edges and is associated with delamination and exfoliation of stone.

*South elevation entrance surround and fountain. Photo by ARG.*

Due to the significance of this artwork, restoration is warranted. It will likely be necessary to essentially rebuild the sculpture and fountain by carefully removing individual units, repairing back-up masonry, and re-setting the slate and terrazzo. Repair of small losses and cracks will also be necessary. In conjunction with this work, analysis for proper conservation treatment should be conducted to determine the causes of discoloration and deterioration of the slate at edges. The plumbing should be inspected, and repaired as required so that the fountain may function as originally designed.

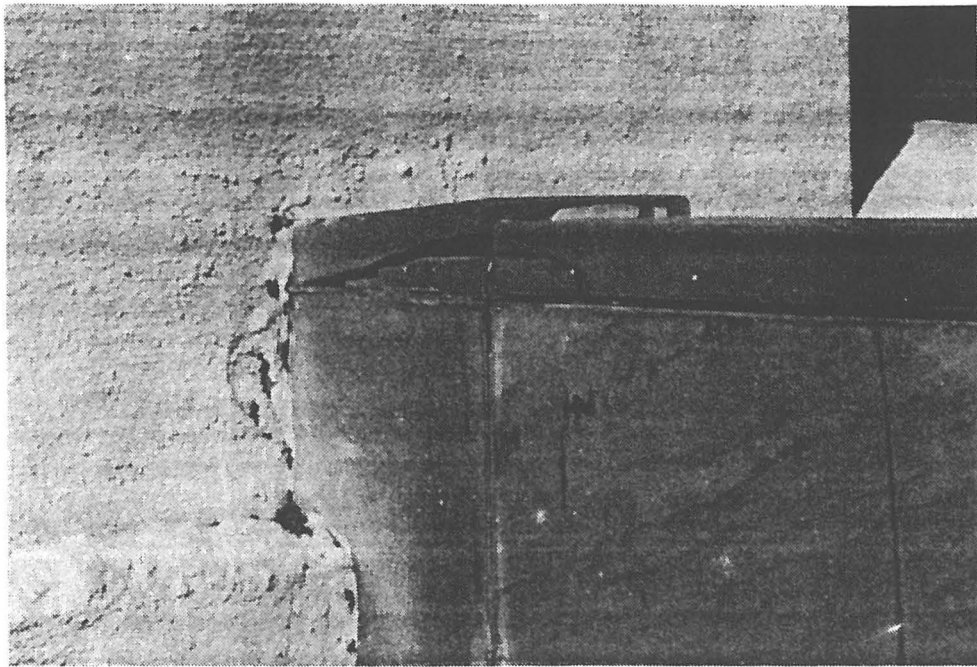
*Cracked and displaced coping stone at fountain. Photo by ARG.*

The loose or broken pieces of masonry which are in danger of being lost by theft would be removed and safely stored. This applies essentially to the fountain coping stones.

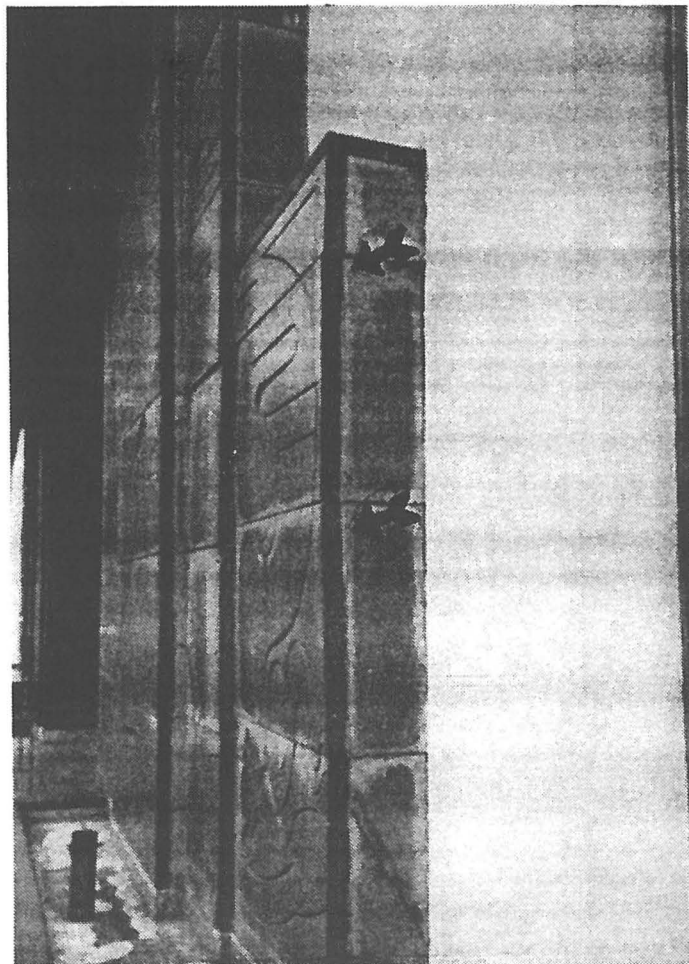
In addition to the above conditions, displacement of fountain and bas-relief masonry panels was also observed. The most critical instance of displacement occurs east of the entrance where two, and perhaps three panels are leaning slightly away from the building (see photo on following page). The implications of detachment of these panels in terms of life-safety are obvious, but also significant would be the loss of or damage to these carvings. Panels attached to the face of the canopy did not appear to have suffered displacement.

*Displaced panel. Photo by ARG.*

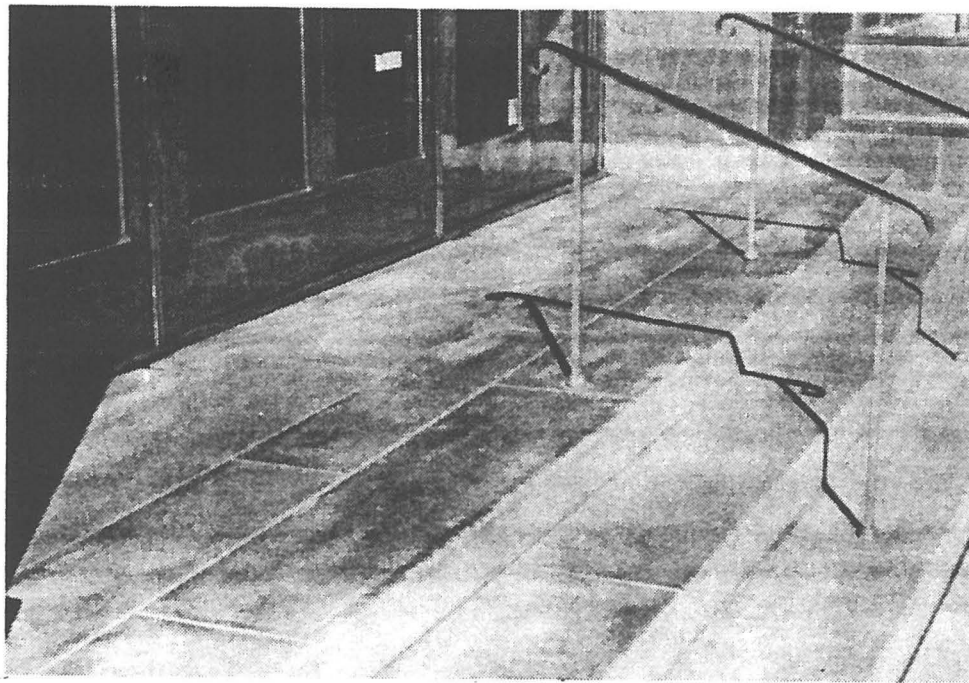
The steps have a general discoloration and blotchiness which appears to have been caused by the application of a sealer or stone treatment product. It is also possible that there has been some corrosion of metal elements in the canopy, and that corrosion laden condensation moisture has dripped onto the steps causing staining. There are approximately 30-feet of open joints.

*Entrance steps detail. Photo by ARG.*

The blotchy appearance of the steps is visually disruptive. It is recommended that the residue of the existing coating be removed, the granite cleaned and stains removed, joints pointed, and the steps left uncoated.

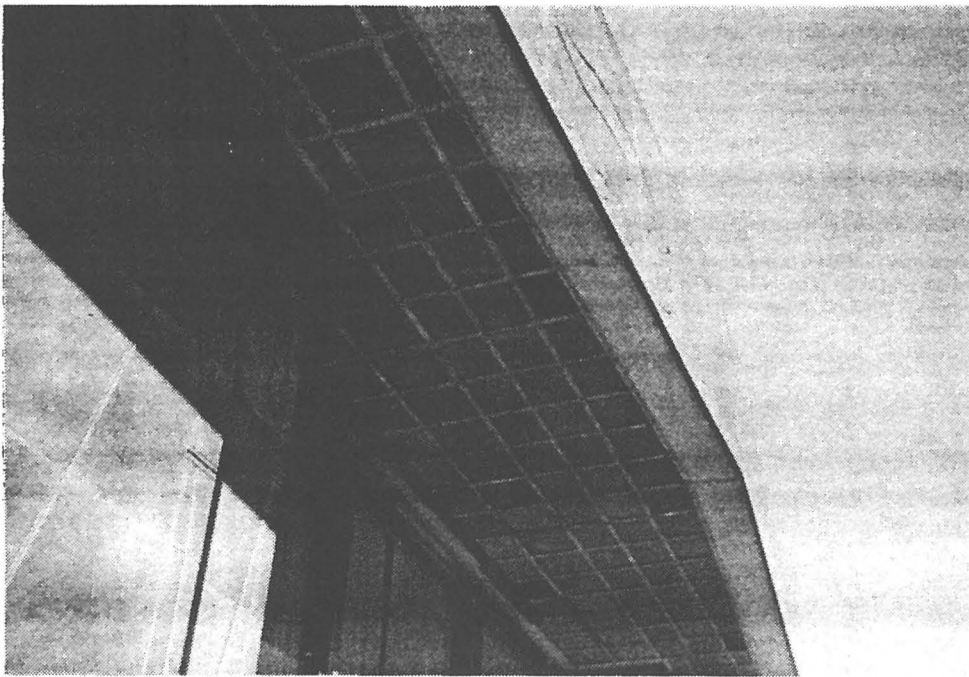
A total of seventeen of the original lites have been replaced either with glass not matching the original, or plywood. Portions of the steel framework were visible from the front edge of the canopy beneath a loose piece of copper flashing. This steel was coated with red lead paint, and appeared to be in good condition. N.P.S. employee Ken Russel of the Maritime Museum indicated he observed no evidence of water intrusion into the canopy when he recently replaced light bulbs in the canopy soffit.

*Soffit of canopy. Photo by ARG.*

It is recommended that glass matching the color and texture of the original glass be located and used to replace those panels which are not original. Some rehabilitation work on the metal gridwork may also be necessary.

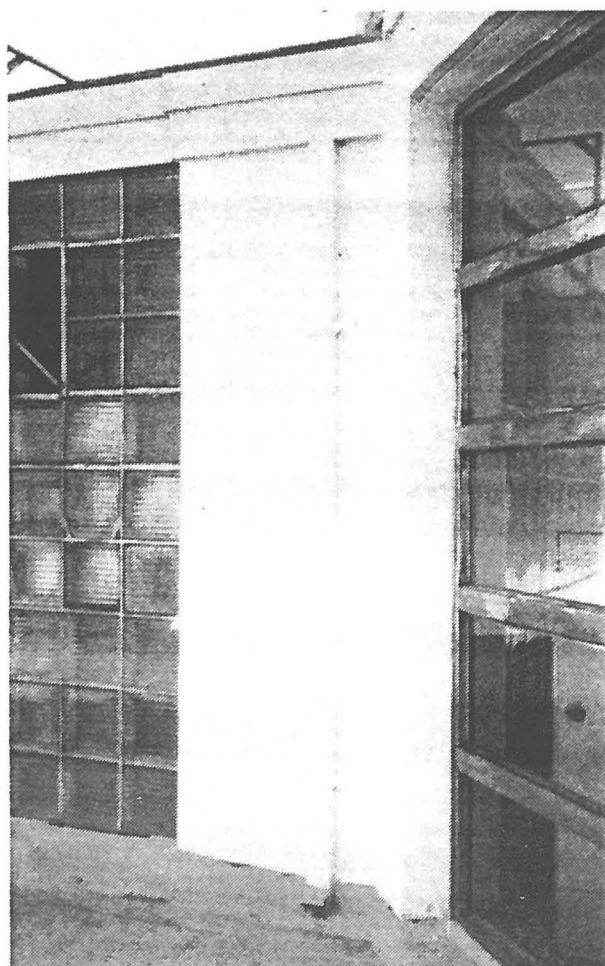
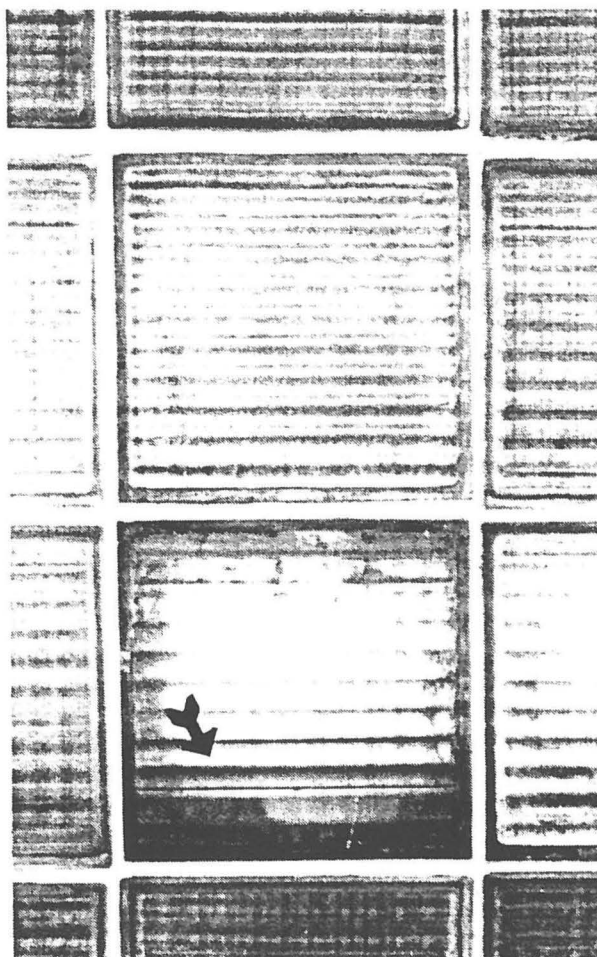
The glass brick wall is in poor condition. A significant number of blocks are cracked, and the mortar between blocks is generally deteriorated. Further, many blocks have become partially filled with water; some are at least half full (see photo on following page). This is not an unique condition for blocks of this age. Glass block was, and still is, manufactured in two halves which are fused together. Typically, the fused seal breaks down and allows water into the block. As the pantry is in an exposed location and block mortar joints are generally open, it is not surprising that wind driven rain has been able to penetrate into the blocks.

*Water in third floor pantry glass block. Photo by ARG.*

Because there is significant damage to the glass wall units, as well as bowing which suggests structural problems, it is recommended that the wall be disassembled and rebuilt using glass block units which match the color, texture and size of the original units. Although it would be preferable to re-use the original blocks, this approach is not advocated for the following reasons:

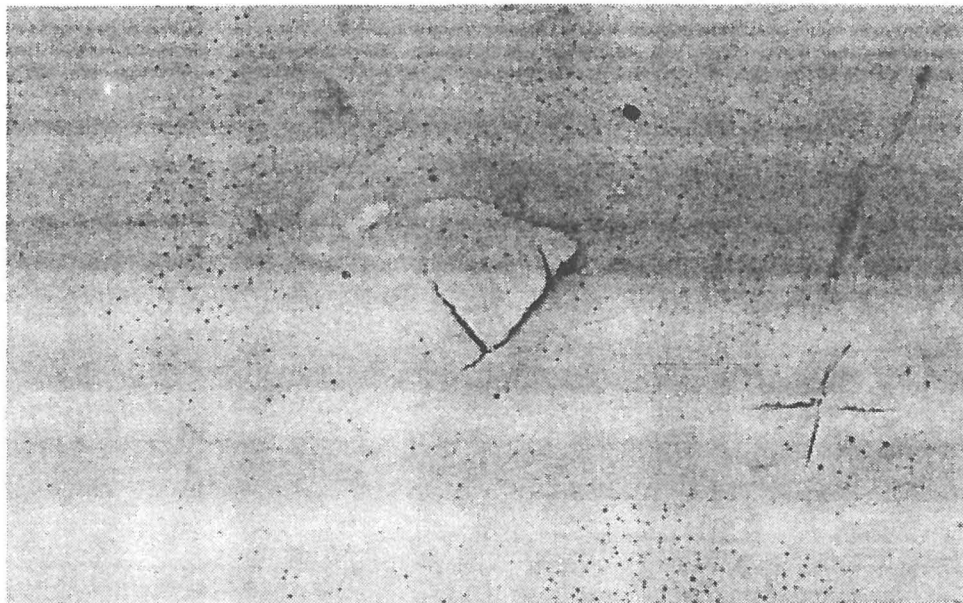
A general survey of the decks was made in order to identify areas where water was likely to penetrate. Damaged or cracked tiles and curbs were difficult to identify as conditions were hidden by the urethane coating. There were several areas where curb damage was obvious, due primarily to expansion of corroding steel imbedded in the concrete. Locations where loose urethane coating was removed during the repair work were examined in order to determine the condition of the pavers. Cracks were noted through tiles and in mortar joints. It was not possible to definitely correlate damaged areas of the roof with areas of water leaks within the building. This suggests that water may be traveling some distance within the building assembly before it appears on interior walls and ceilings.

*Blister in urethane coating which covers roof decks. Photo by ARG.*

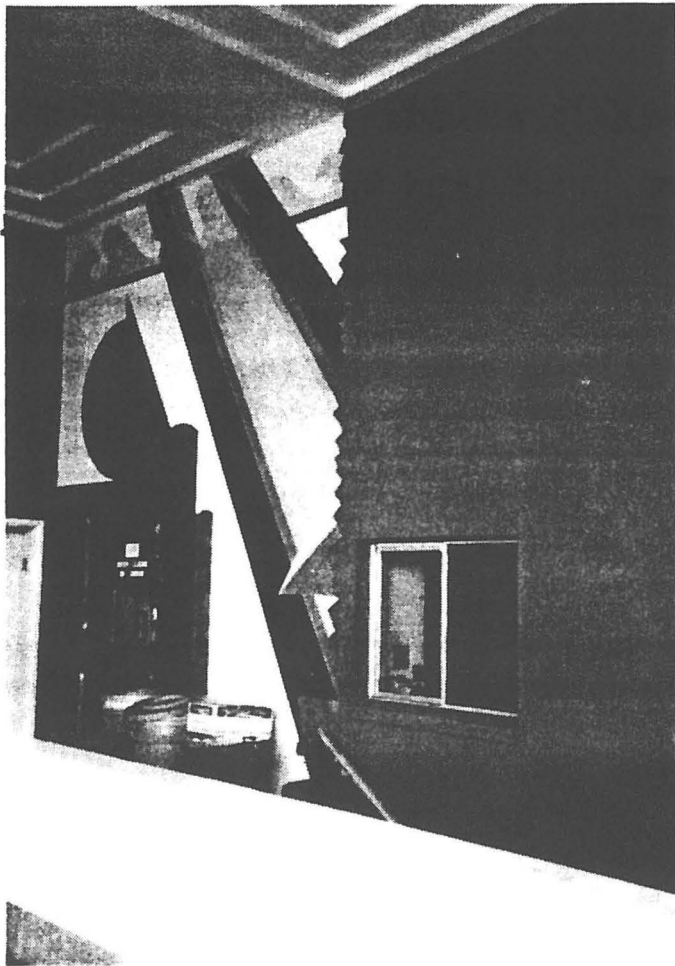
The deck is in good condition with no significant damage. The tiles appeared to be well adhered to the wall, and are in generally good condition with the exception of tiles which have a metallic luster glaze many of which have changed color due presumably to oxidation.

*Incomplete tile mural on veranda exterior wall. Photo by ARG.*

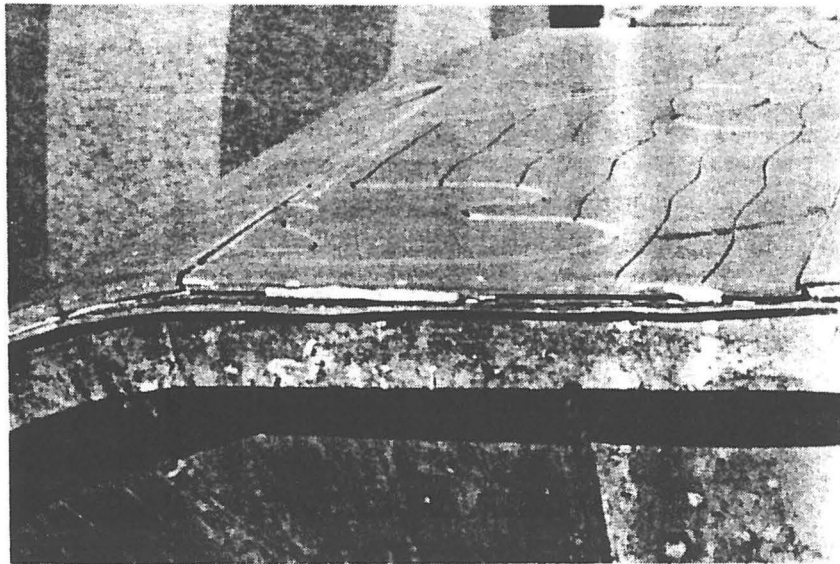
These roofs appeared to be in generally good condition. The copper cap flashing along the front edge of the canopy was loose.

*South elevation entrance canopy copper roof showing open joint and loose cap flashing. Photo by ARG.*

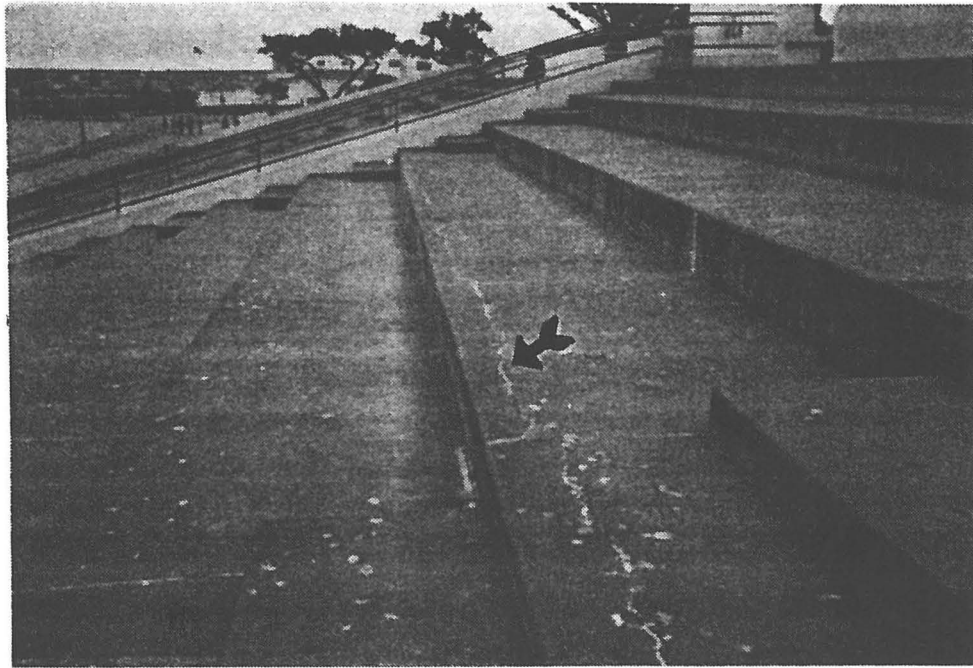
some damage. There was no significant difference between exposed surfaces of the three bleachers; cracks and spalls were noted on each. This suggests that moisture is penetrating all of the bleachers to some degree, and that deterioration will continue.

*Failed sealant in cracks of bleacher. Photo by ARG.*

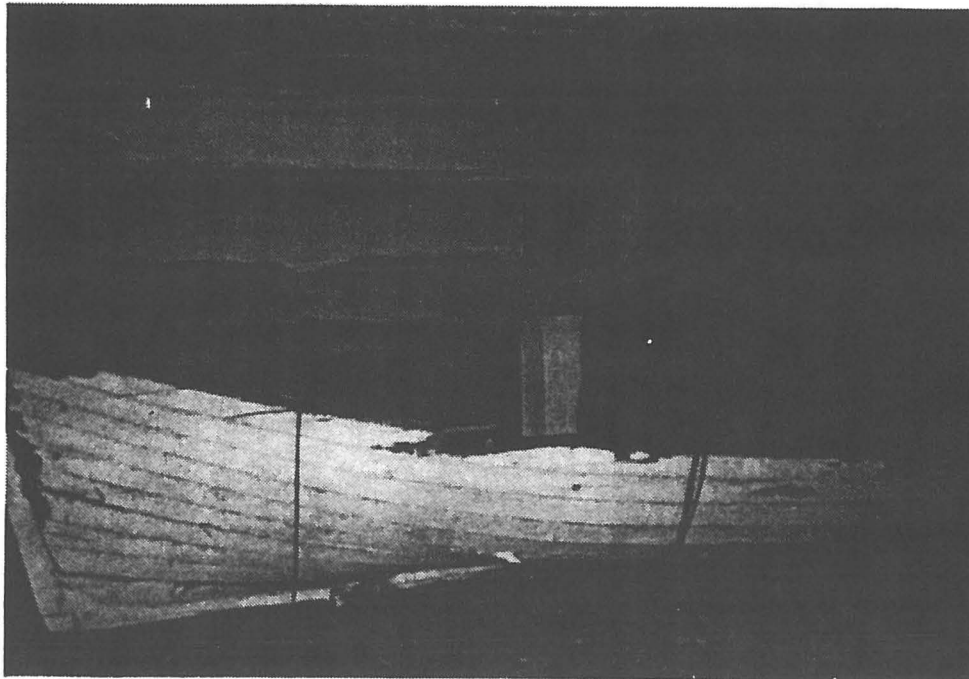
*Spalled concrete under easternmost bleacher. Photo by ARG.*

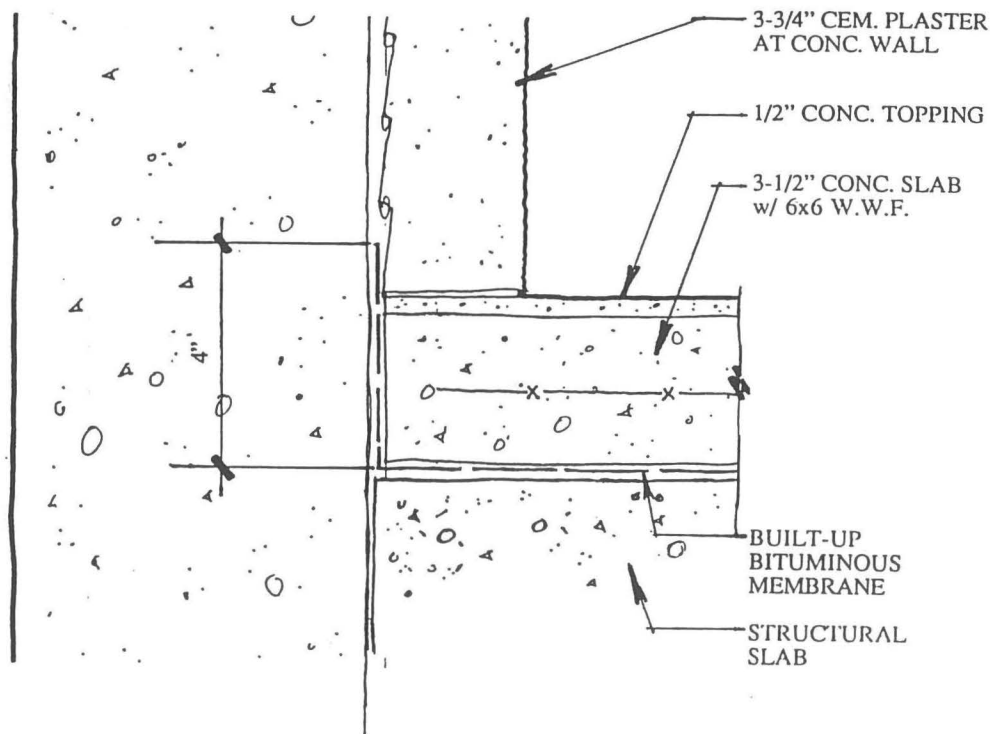
RAMP AT BUILDING DETAIL

The driveways have numerous cracks as well as open joints at the junction of the driveway and building, and driveway and retaining walls. There have been attempts to seal some open joints, but the sealant has deteriorated and now provides no protection. Beneath the east end driveway, water has entered the offices of the museum curatorial staff. It appears quite likely that the path of entry is through the open joint at the junction of the museum building wall and driveway, and that the membrane itself is functional.

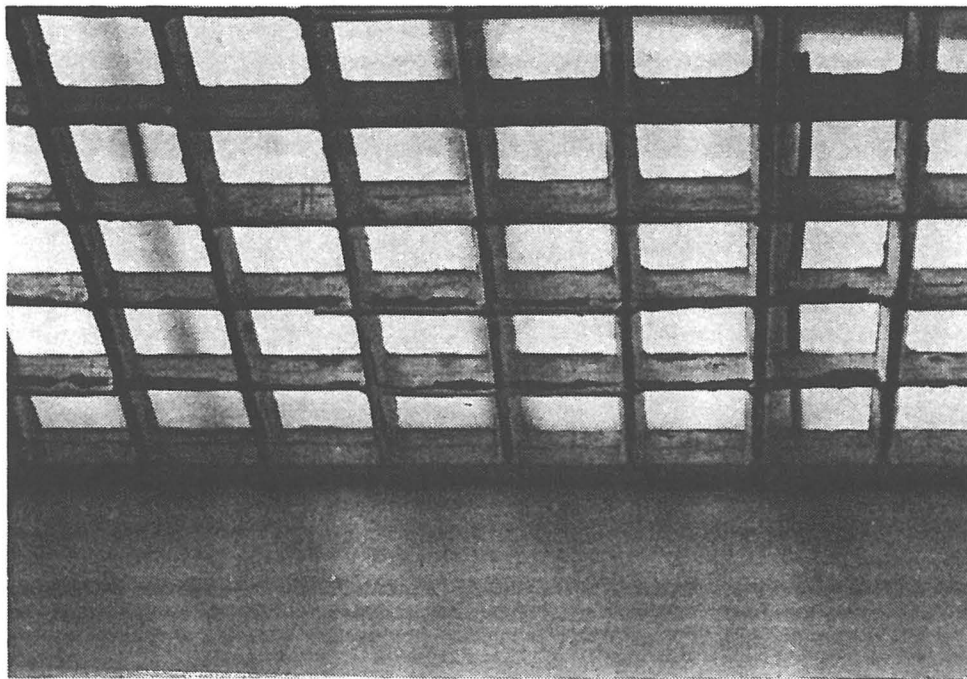
When inspected from the interior, it appeared that all of the skylights had leaked at some time in the past directly through the glass lites, and at the concrete curbs. Green biological staining remains on several interior curb walls, and the majority of wire glass lites were cracked and discolored. Spalling of the concrete frames, caused by corrosion of reinforcing steel, was common. Condensation was prevalent on glass and plastic surfaces in the air space between the original skylights and the skylight covers with the exception of the newer covers which appeared to have adequate ventilation. NPS personnel familiar with the condition of the subterranean space report that the new covers have been successful in preventing water from entering the building through the skylights they protect.

*Spalling of skylight concrete gridworks frames. Photo by ARG.*
